Kirby Morgan Dive Systems, Inc.®

1430 Jason Way, Santa Maria, California 93455

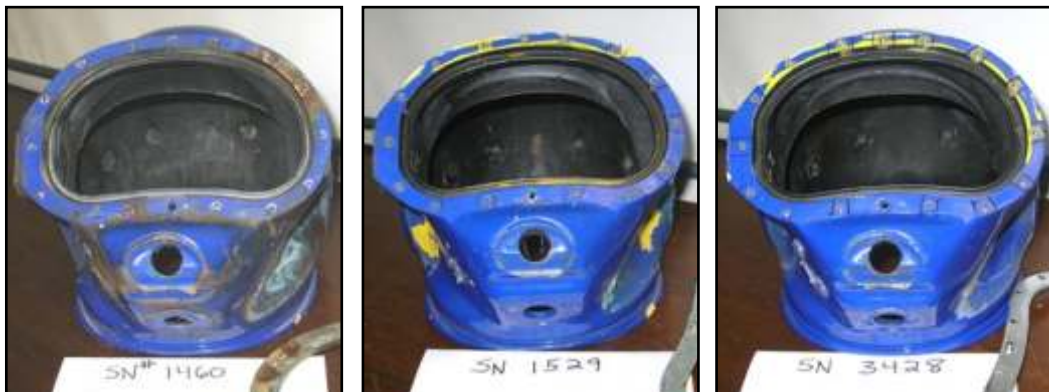
This is how the three stripped helmets appeared when they were received by the repair facility.

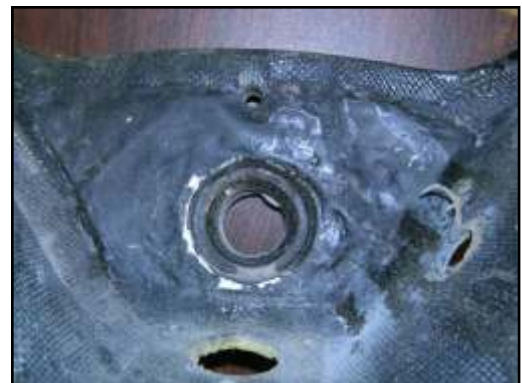
The interior of one of the painted helmets shows obvious sub-standard repair work.

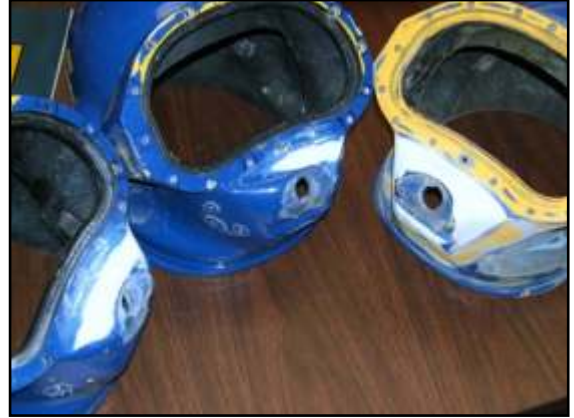
The unauthorized paint job on these helmets concealed repairs performed with sub-standard materials.
